Manhole Inspection Summary

Manhole # S31U1_001MH

Insp Date: **4/9/09 1:44 PM**

Location Address: **3520 Round Rd.**

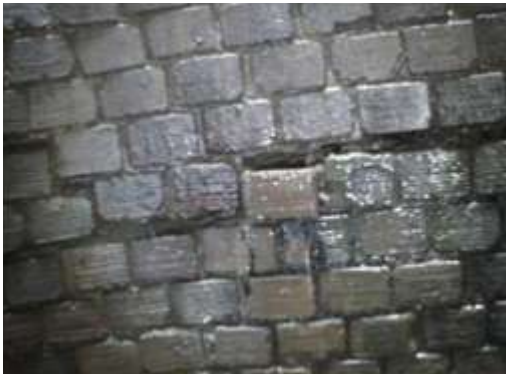
Defect 1

Infiltration: ☐ None ☐ Joint ☒ **Cracks** ☐ Mortar ☐ Roots ☒ **Wall**

wall cracks with steady infiltration.

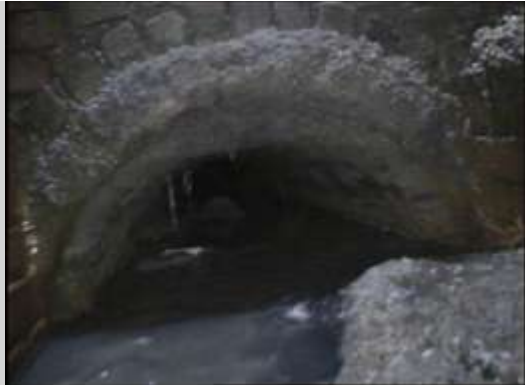
12 O'Clock Outflow

24 in. Circular Gravity Sewer
Pipe Out @ 12 O'Clock

Pipe Height: **18** (in.) Rod and Bar (Angled)
Pipe Material: **Clay** ☐ Pipe Lined
Invert Depth: **17.00** (ft.) Flow Characteristics: **Fast**
Deposits: ☒ None ☐ Mud ☐ ~~Gravy~~ ☐ Debris ☐ Grease
Silt Depth: (in.) Deposits Extent:
Infiltration: **None** Pipe Seal Cond: **Sound**

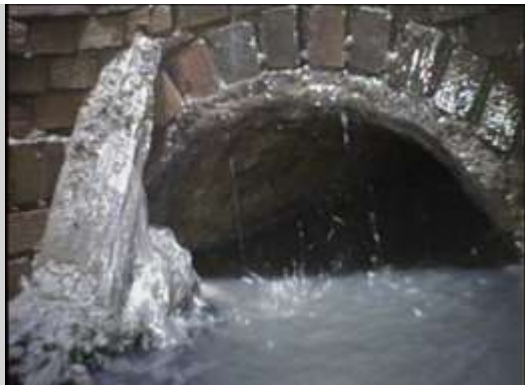
6 O'Clock Inflow

30 in. Circular Gravity Sewer
Pipe In @ 6 O'Clock

Pipe Height: **18** (in.) Rod and Bar (Angled)
Pipe Material: **Clay** ☐ Pipe Lined
Invert Depth: **17.18** (ft.) Flow Characteristics: **Fast**
Deposits: ☐ None ☐ Mud ☒ ~~Gravy~~ ☐ Debris ☐ Grease
Silt Depth: **4** (in.) Deposits Extent: **Medium**
Infiltration: **None** Pipe Seal Cond: **Sound**
